DEPARTMENT OF NATURAL RESOURCES  
DIVISION OF OIL, GAS AND MINING

SUBJECT: Site Inspection, American Gilsonite Company, Bonanza Mine, M/047/010, Uintah County, Utah

Date of Inspection: August 15, 2003

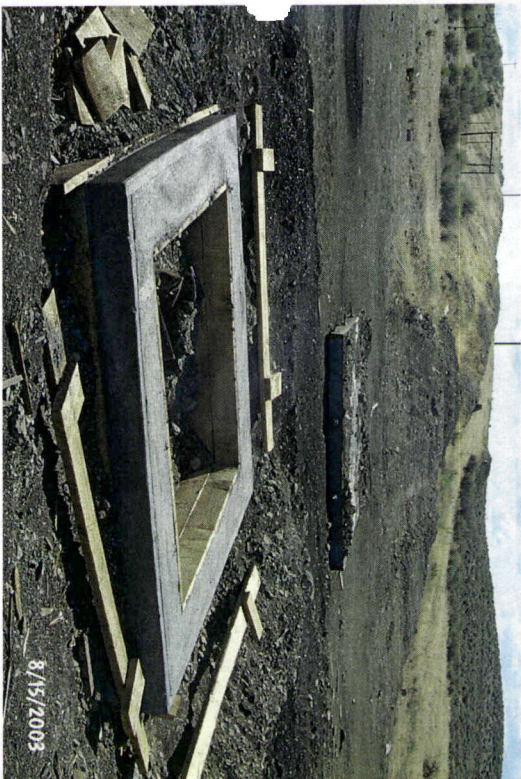
The capping method the operator is trying includes digging around the edge of the shaft down to bedrock, building forms, and pouring concrete footers. The footers are reinforced and are about eighteen inches thick. The cap is also reinforced and is about ten inches thick. The site where the operator has poured the footers is shown in Photo 1.

Photo 1. Footers at the I-16 shaft.

Some degree of repair, up to complete reconstruction, needs to be done at all the sites except the first site we visited (I-16) where the operator has poured footers. Mr. Jensen and I agreed the buried footers for the headframe or the bin could stay at I-16.

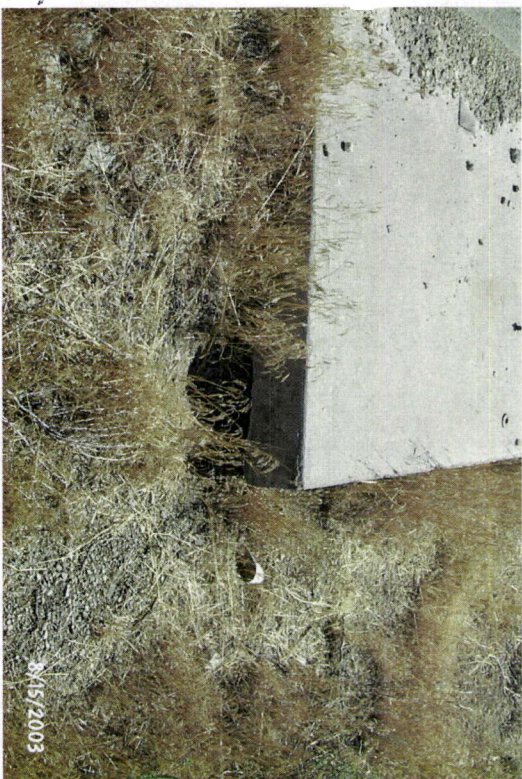
We visited about three other sites where the operator has tried placing the caps on the surface or on concrete with no foundation extending to bedrock. The result has been animals burrowing under the concrete (Photos 2 and 4) or the ground under the concrete becoming otherwise unstable (Photo 3).

Photo 2. Burrow under a concrete slab at one of the Little Emma sites.

At LE-8, the existing concrete could be used as forms for the new footers. The caps at the other sites, including LE-10 and one of the other Little Emma shafts, cannot be considered stable and need to be redone.

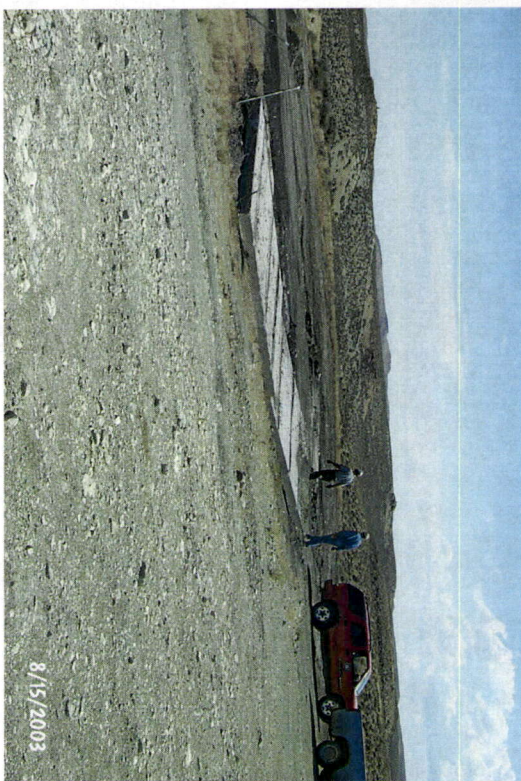
Photo 3. Caps placed basically on the ground at LE-10. Note how irregular they are.

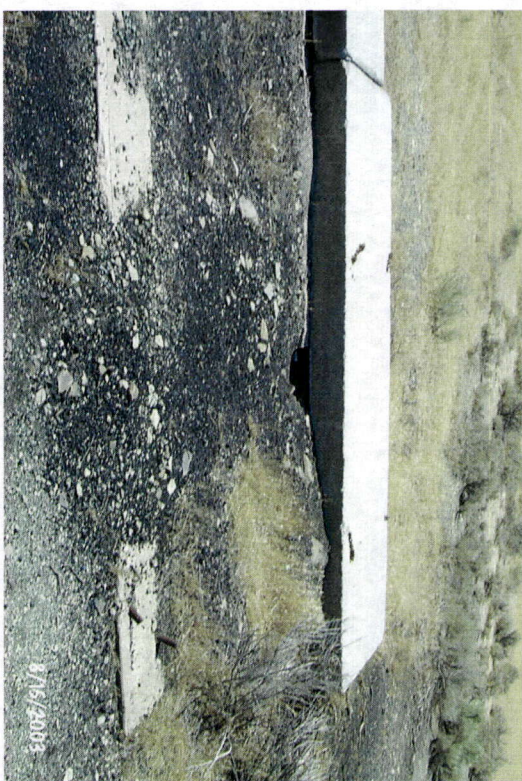
Photo 4. Cap at LE 8. Note the burrow.
